FLOOD PLAIN MANAGEMENT STUDY
for the
TOWN OF EAGAR
Apache County, Arizona

prepared by the
**UNITED STATES DEPARTMENT OF AGRICULTURE
SOIL CONSERVATION SERVICE
PHOENIX, ARIZONA**
in cooperation with the
**TOWN OF EAGAR
APACHE COUNTY**
**APACHE NATURAL RESOURCE CONSERVATION DISTRICT
ARIZONA DEPARTMENT OF WATER RESOURCES**

JUNE 1986

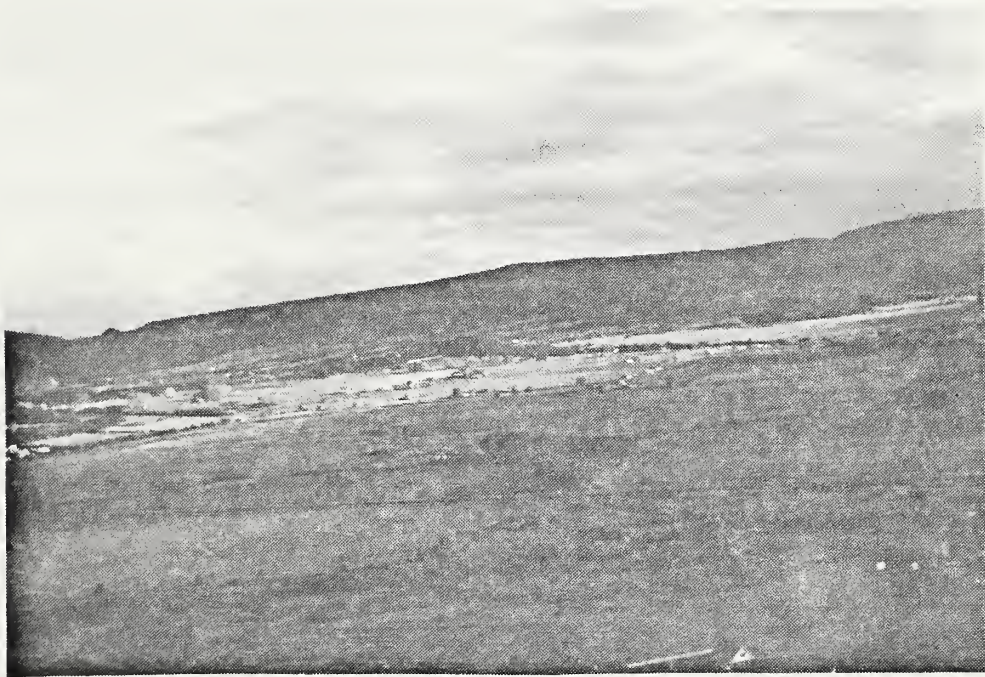
Fig. 2

Water Canyon Outlet into Little Colorado River

Looking south-southeast at Water Canyon Channel and its flood plain. The Little Colorado River is in foreground

Irrigated-Subirrigated Pastures/Cropland: Apple and stone fruit orchards, corn fields, alfalfa, pasture grasses, gardens and native vegetation pastures provide a wealth of seed, fruit and forage for wildlife. The areas along the Little Colorado River provide seasonal habitat for wading birds and waterfowl in addition to livestock forage. Refer to Fig. 2.

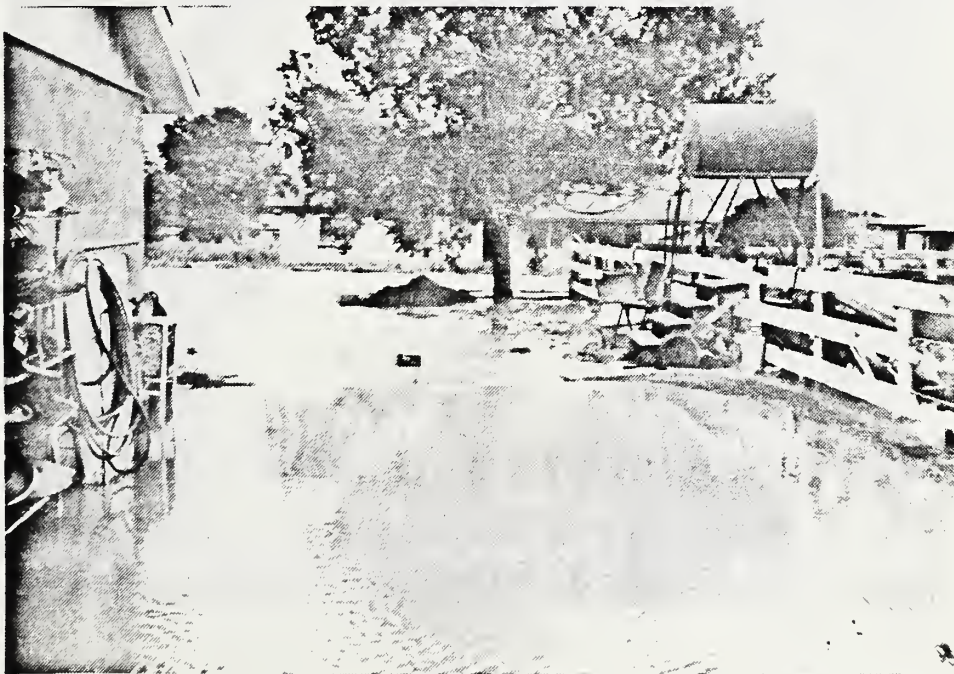
Fig. 3
SE Part of Eagar, Sept. 1984 Flood
Typical flooding along Butler Street

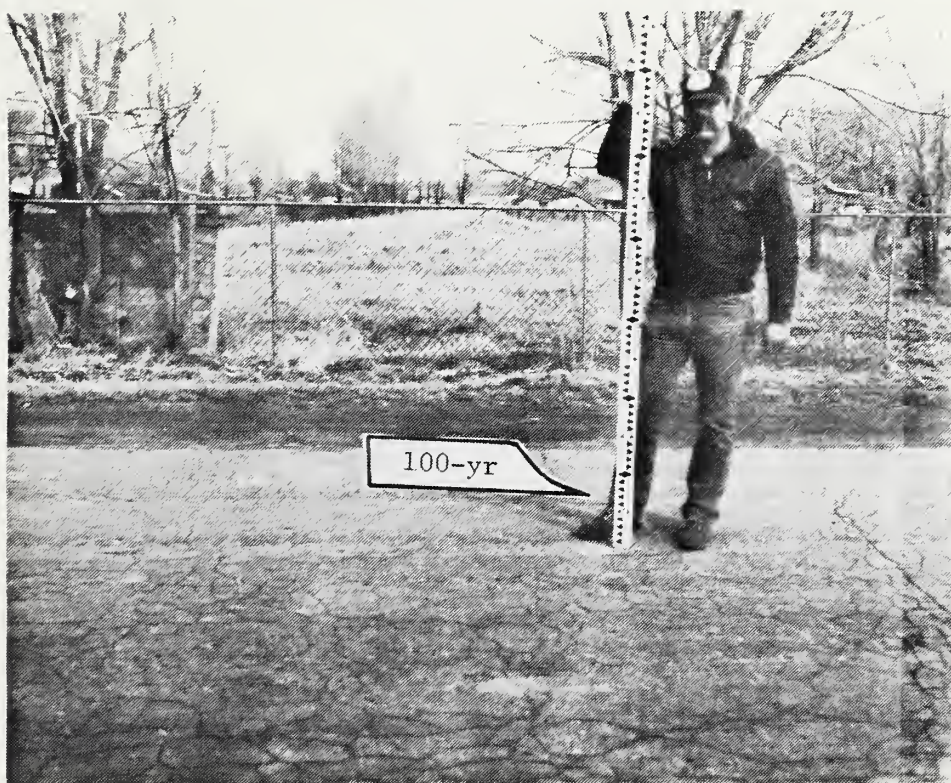
7th Street, between Main Street and Eagar
Avenue; looking north. Approx. depth 0.7 ft.

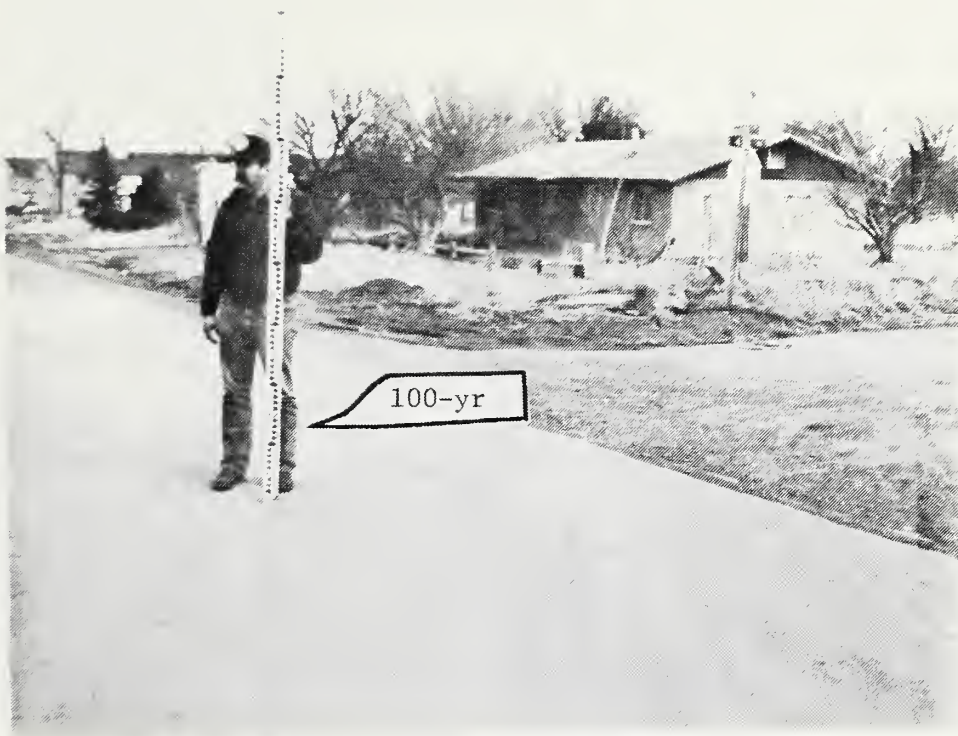
Butler Avenue at 4th Street
Approx. depth 1.2 ft.

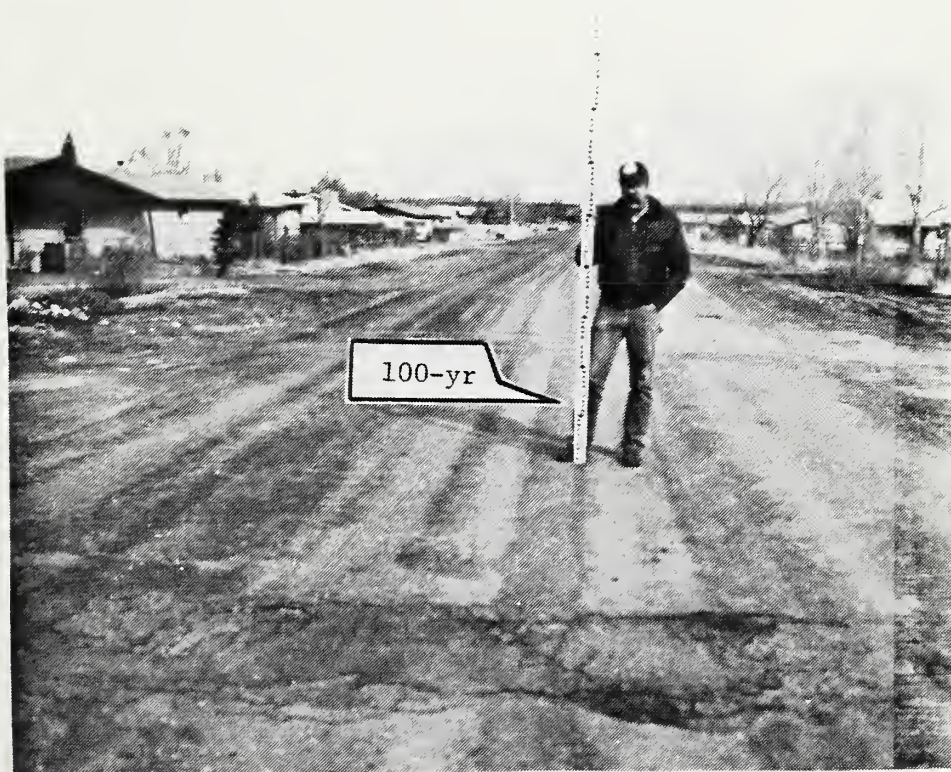
Butler Avenue near 3rd Street
Approx. depth 1.2 ft.

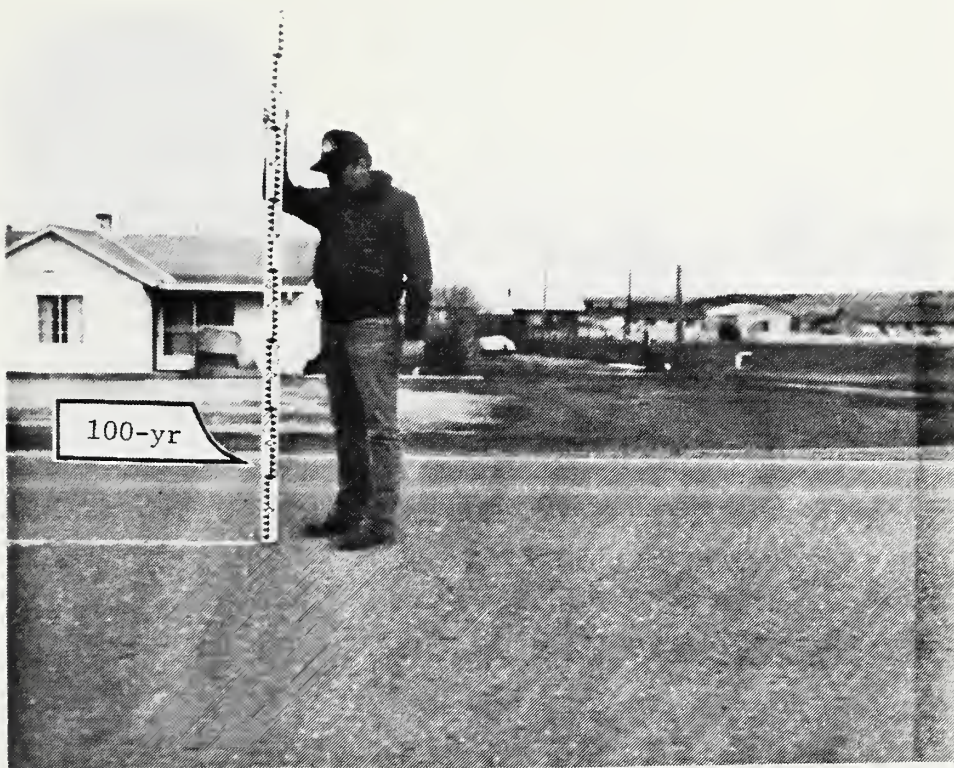
Central between Butler and Hamblin Avenues
Approx. depth 1.1 ft.

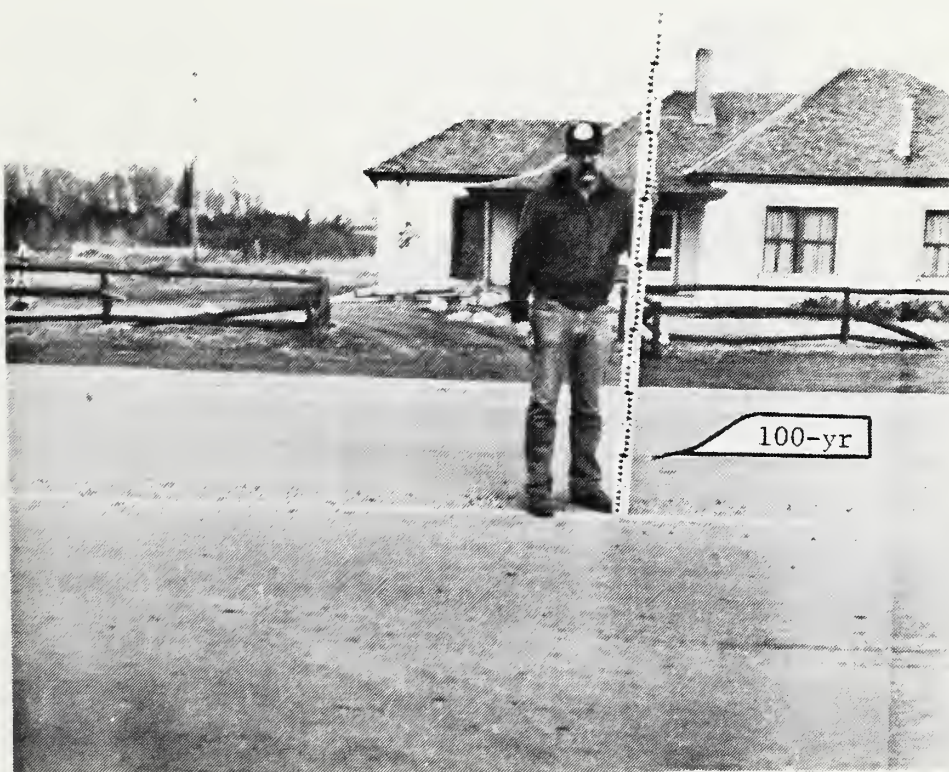
Central near Main Street
Approx. depth 1.0 ft.

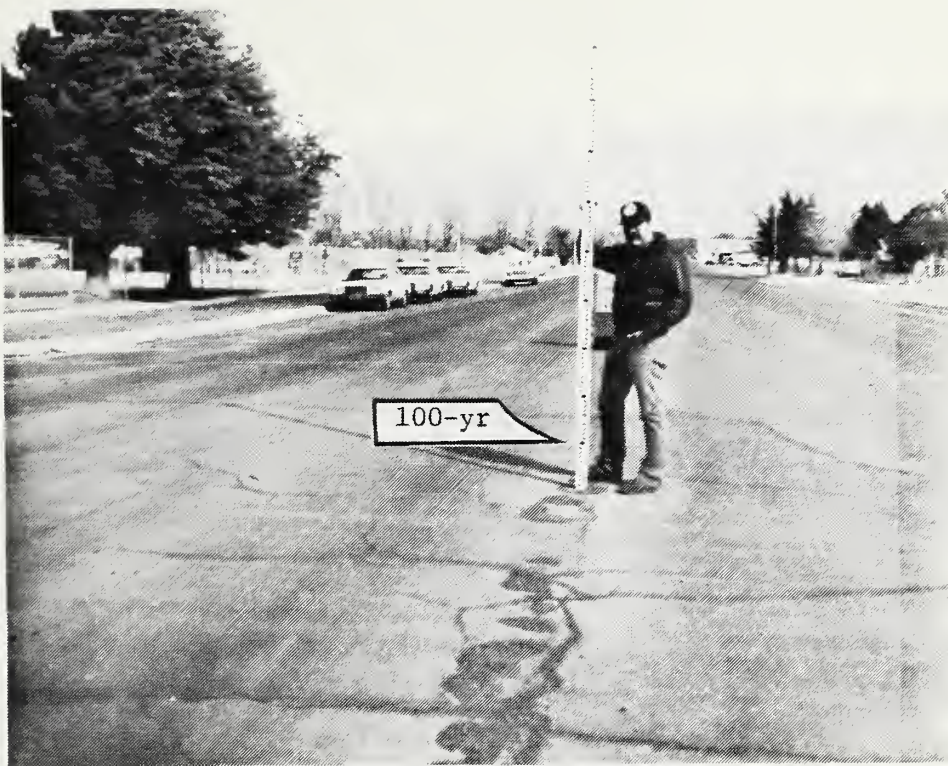
Main Street near 2nd Street
Approx. depth 1.0 ft.

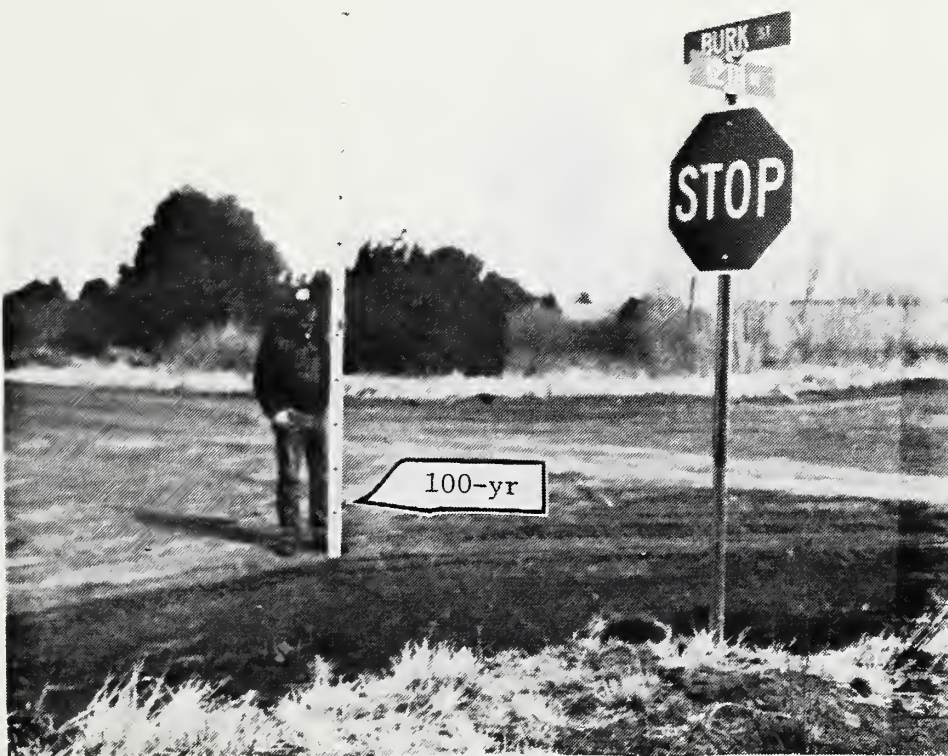
Intersection of Burk and 12th Streets
Water Canyon
Approx. depth 1.2ft.

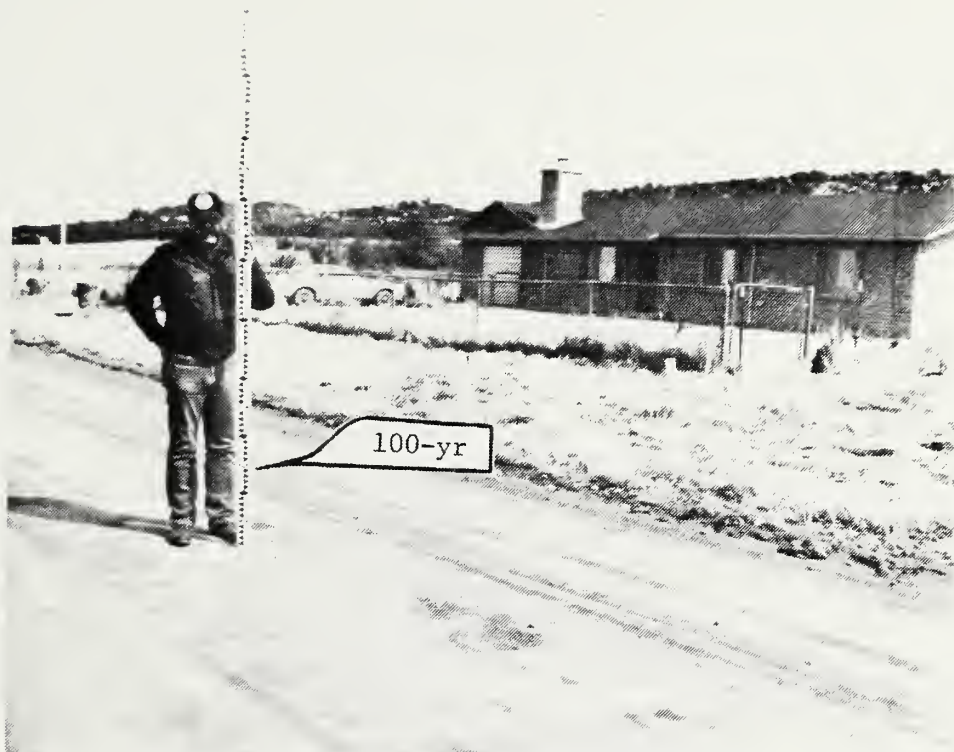
River Road near 4th Street; looking
north-northeast; Water Canyon
Approx. depth 1.5 ft.

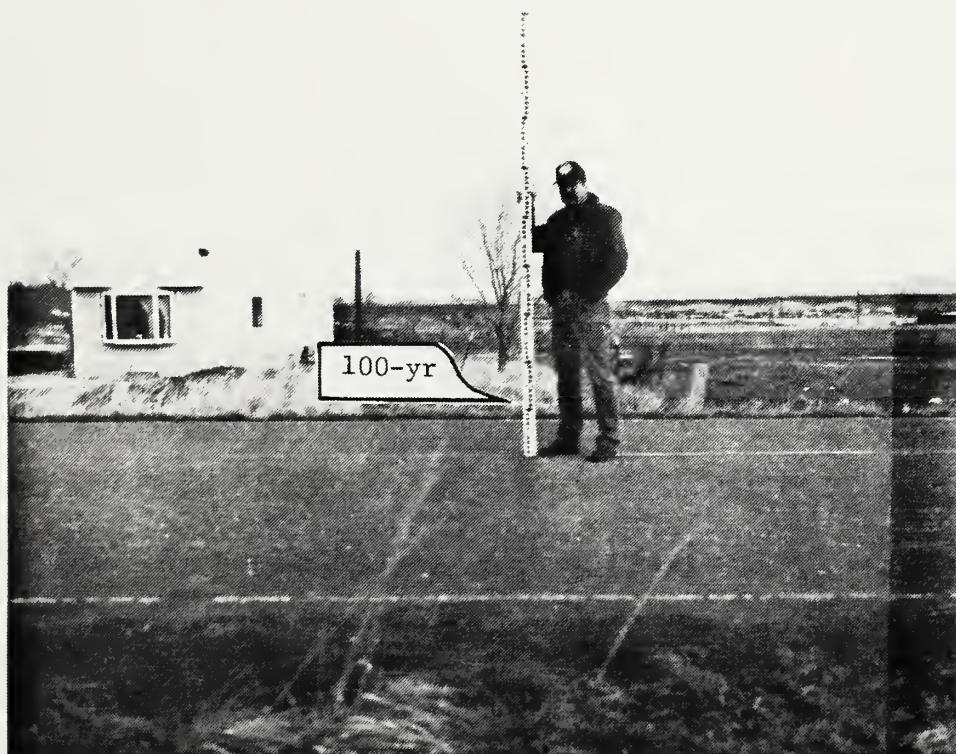
Central (Highway 180) near Poverty Flat Road
Robertson Hollow
Approx. depth 1.1 ft.
